RECAPP Facility Evaluation Report

Edmonton School District No. 7

Greenfield School

B3138A
Edmonton

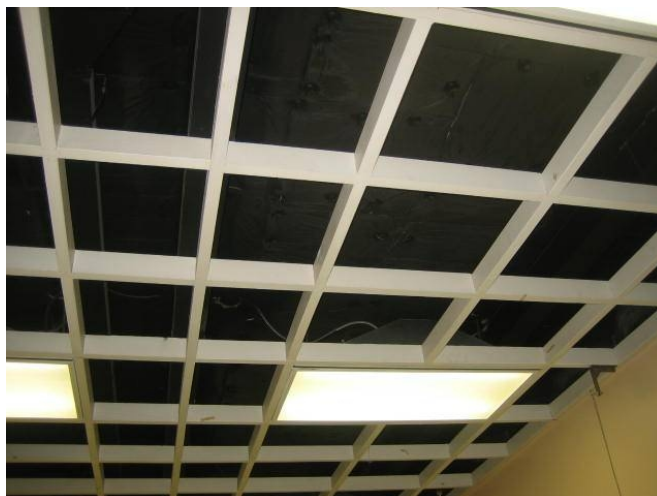
Greenfield_0105.JPG

| <u>Rating</u> | <u>Installed</u> | <u>Design Life</u> | <u>Updated</u> |
|---|---|---|---|
| 4 - Acceptable | 1968 | 0 | MAR-12 |

Event: Replace Ceiling Grid With Acoustic Tile - (2800m2)
