RECAPP Facility Evaluation Report

Edmonton School District No. 7

McKernan Elementary / Junior High School

Evaluation Company: N53 Architecture Inc.
Evaluation Date: December 11 2012
Evaluator Name: Jason Porterfield

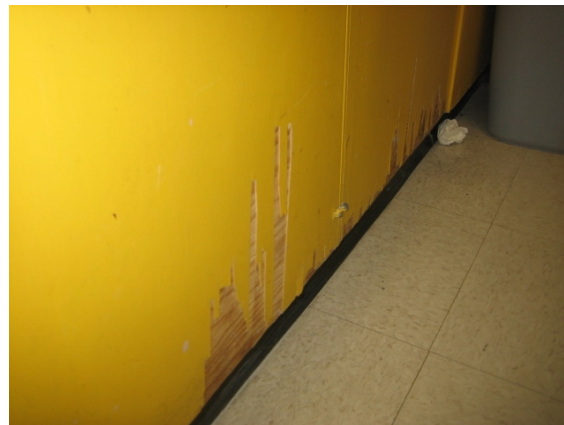
IMG_9751.jpg

The carpet in the classrooms, library, music room and computer room should be replaced as it is damaged and ripped. The fixed casework throughout is in need of replacement. It is worn and the plastic laminate countertops are starting to peel
