RECAPP Facility Evaluation Report

Edmonton School District No. 7

North Edmonton Elementary School

B3232A
Edmonton

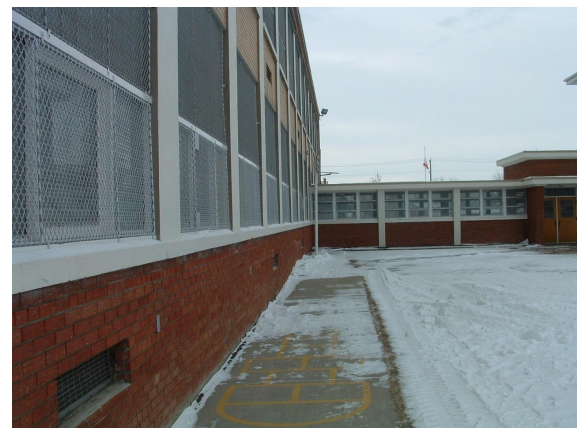
G2030.04 Rigid Pedestrian Pavement (Concrete)*

(1955) Two long concrete sidewalks, one on the north side (leading from the building to 129 Avenue) and another on the south side (leading from the building to 128 Avenue. Concrete sidewalks along the south sides of the 1917 building and 1995 addition. A wide concrete sidewalk at the existing main entrance at NE corner of the 1955 addition.

<u>Type</u>	<u>Year</u>	<u>Cost</u>	<u>Priority</u>
Repair	2008	\$3,000	Medium
