RECAPP Facility Evaluation Report

Medicine Hat S Dist #76

Central Park School

B3759A

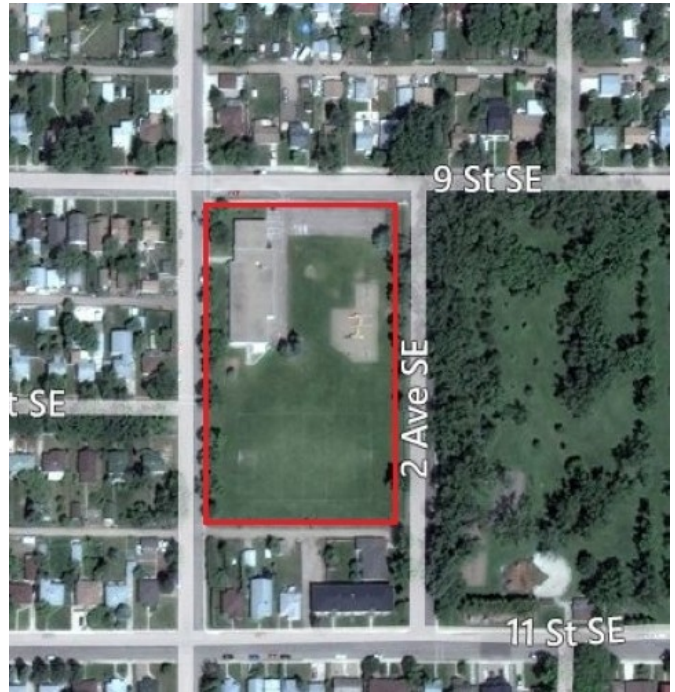
Site Doc Photo (Small).jpg

Building B3759A is located at 945 - 1 Avenue SE, Medicine, Alberta. The Site is located southeast of 9 Street SE and 1 Avenue SE intersection and access to the Site is provided via 9 Street SE & 1 Avenue SE. The Site consists of a one-storey, stand-alone school with three moveable portable located on the south section section of the building. The Site coverage is predominantly grass with mature deciduous trees, asphalt paved parking lot and driveway, an outdoor basketball court and a playground. The building faces west, surrounded with existing residential areas.

<u>Rating</u>	<u>Installed</u>	<u>Design Life</u>	<u>Updated</u>
4 - Acceptable	2013	0	MAR-13
