RECAPP Facility Evaluation Report

Sturgeon School Div #24

Sturgeon Composite High School

Evaluation Company: Robert Irlam Consulting Inc.
Evaluation Date: August 16 2011
Evaluator Name: J. R. Irlam

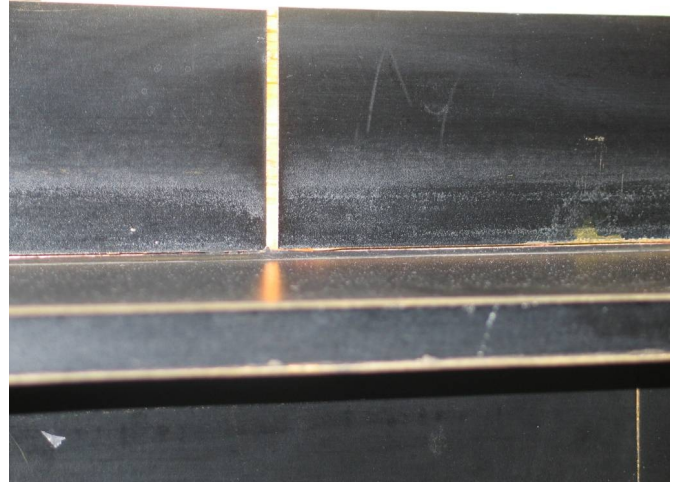
IMG_3369.JPG

There is fixed casework throughout the school including study carrels in the library, book shelves in the classrooms and library, laminate counter in science rooms and vanities in wash rooms.

<u>Rating</u>	<u>Installed</u>	<u>Design Life</u>	<u>Updated</u>
4 - Acceptable	1976	35	JAN-12

Event: Replace 200m fixed case work
