RECAPP Facility Evaluation Report

Bev Facey Community High School

B4004A
Sherwood Park

Evaluation Company: Kenneth M. Lee Architect
Evaluation Date: July 17 2007
Evaluator Name: Ken Lee

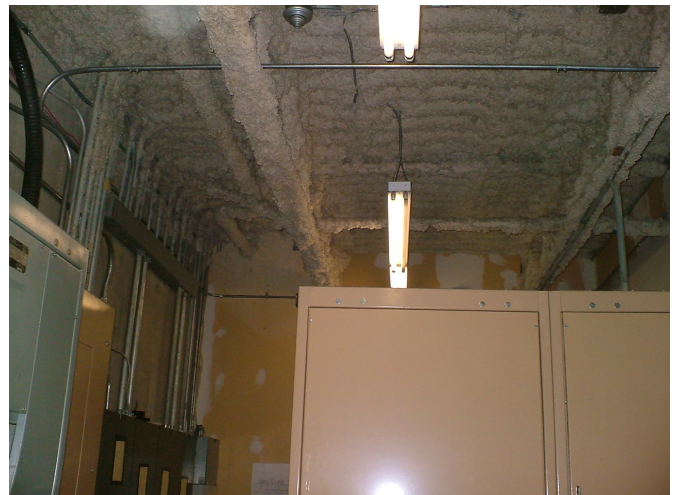
B1020.01 Roof Structural Frame* - 1980 Section

Steel deck on steel joists & steel breams supported by concrete block walls and steel columns.

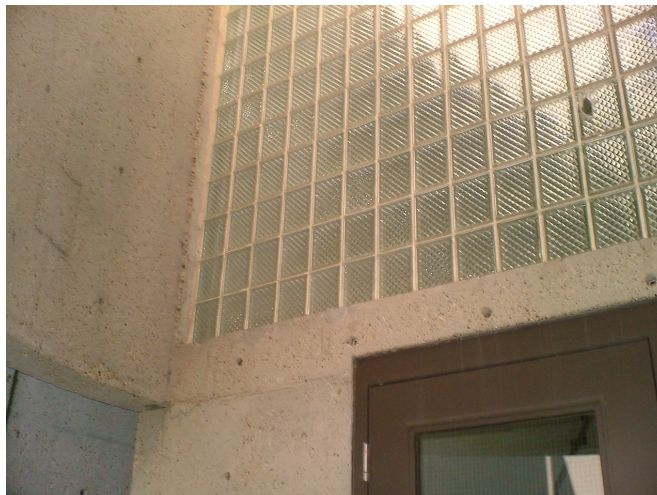
B2010.02.01 Cast-in-place Concrete:Ext.Wall Const* - 1980 Section

Cast-in-place concrete exterior walls for stairwell and some areas.

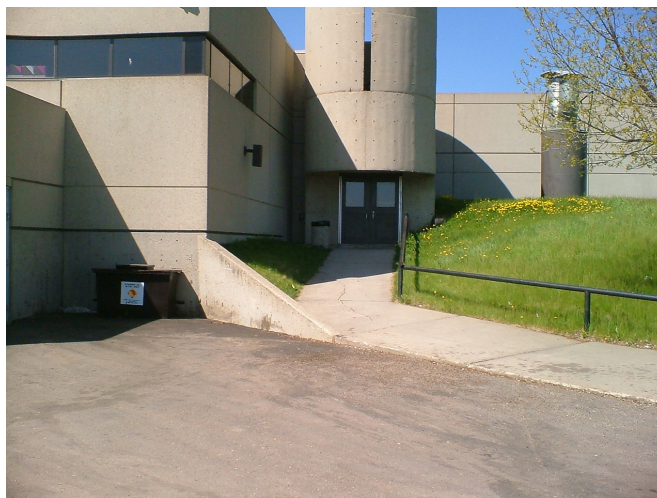
B2010.02.03 Masonry Units: Ext. Wall Const.* - 1980 Section

Concrete block walls.

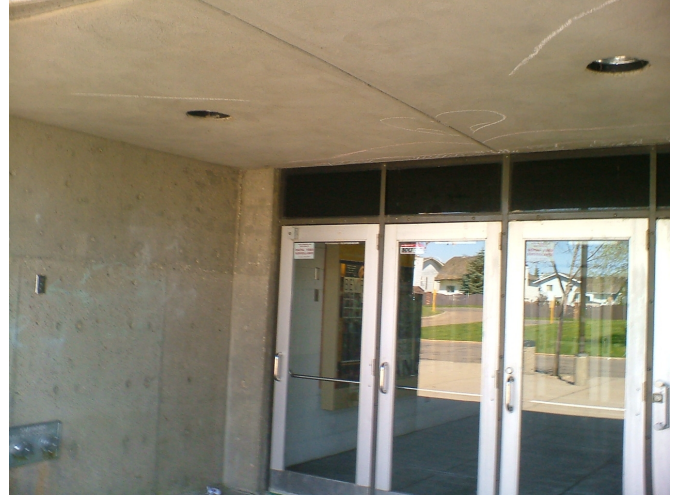
B2020.01.01.02 Aluminum Windows (Glass & Frame) - 1980 Section**

Aluminum windows.

Event: Replace aluminum windows.

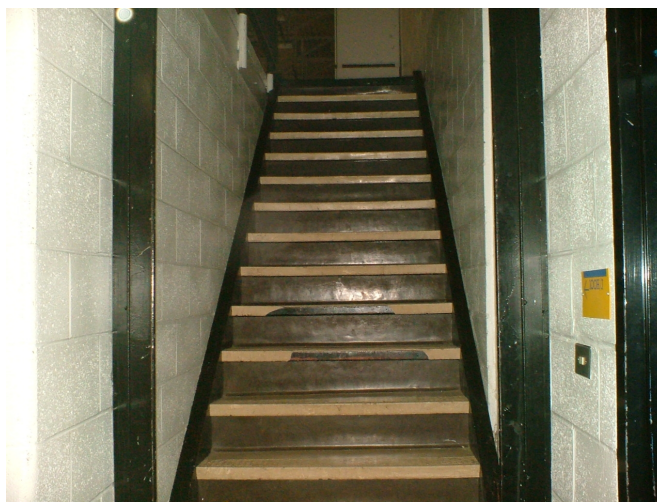
C2020.08 Stair Railings and Balustrades*

Stair railings and balustrades constructed of top & bottom steel pipe rails and supported by steel pipe posts completed with steel wire screen.

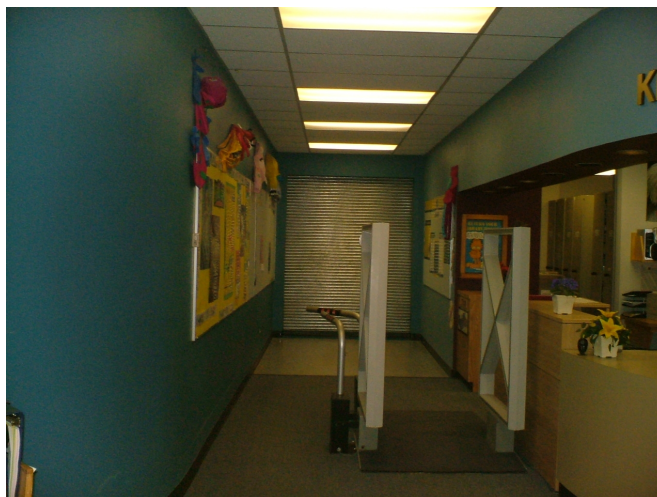
D5030.02.04 Video Surveillance -**

24 Video Surveillance cameras located through out the school, by Baltco.

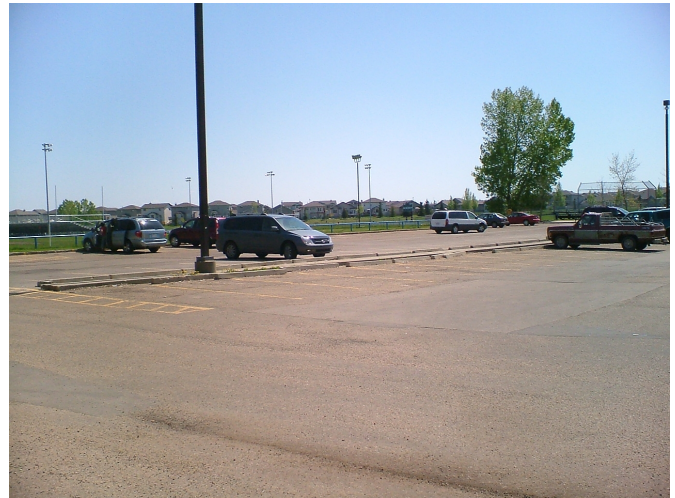
G2020.06.03 Parking Lot Signs*

Parking lot signs for staff stalls, visitors stalls, handicapped stalls, student stalls, service vehicle stalls and school bus loading & unloading zone.

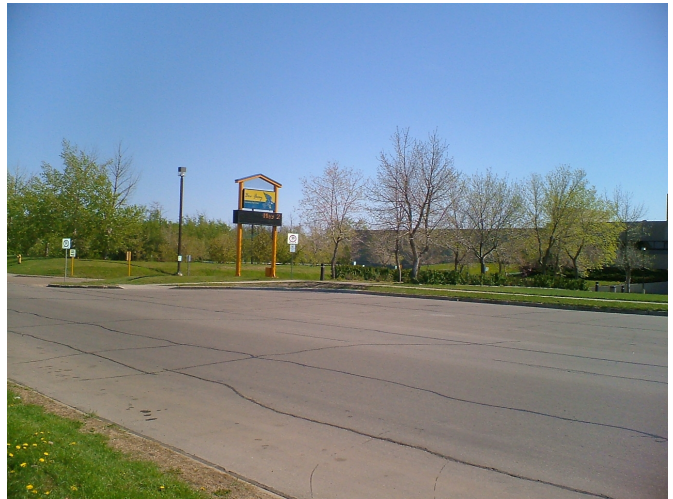
G2040.08 Flagpoles* -

One flagpole on a east lawn facing Colwill Boulevard.

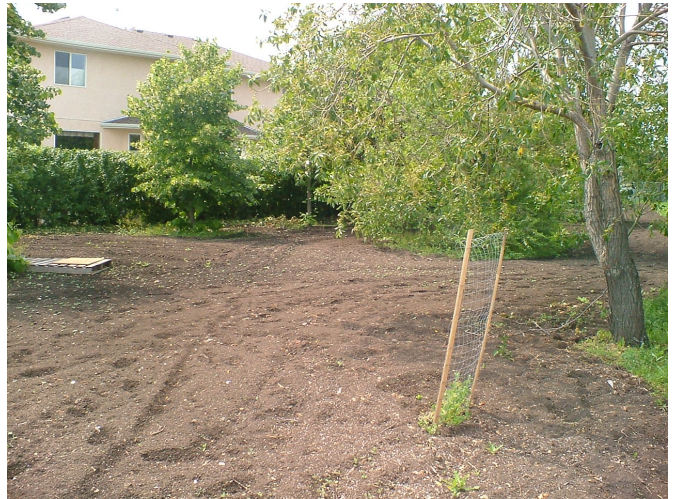
G2050.05 Trees, Plants and Ground Covers* -

Trees and plants in west lawns. Trees in east and north lawns. Trees and shrubs in the seeding area of horticulture south of the south parking lot.
