RECAPP Facility Evaluation Report

Mayerthorpe Jr. / Sr. High School

B3754A
Mayerthorpe

Evaluation Company: Francis Ng Architect Ltd.
Evaluation Date: October 4 2006
Evaluator Name: Francis Ng

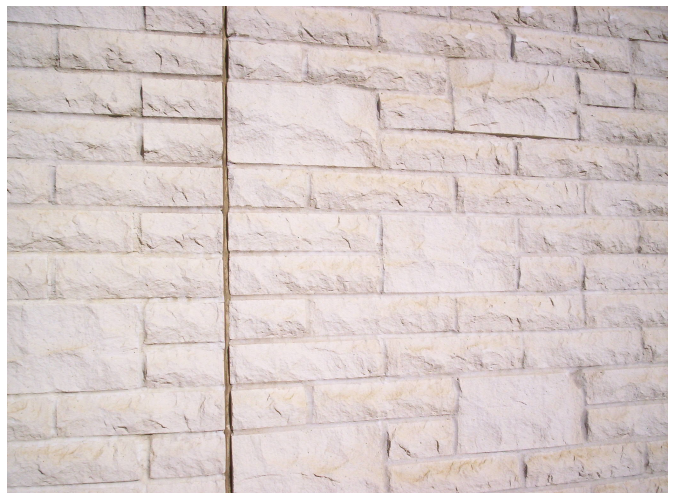
School has control joints between (1967) Addition and (1992) Addition; between (1967) Addition and (1996) Addition.

<u>Rating</u>	<u>Installed</u>	<u>Design Life</u>	<u>Updated</u>
4 - Acceptable	0	75	MAR-07

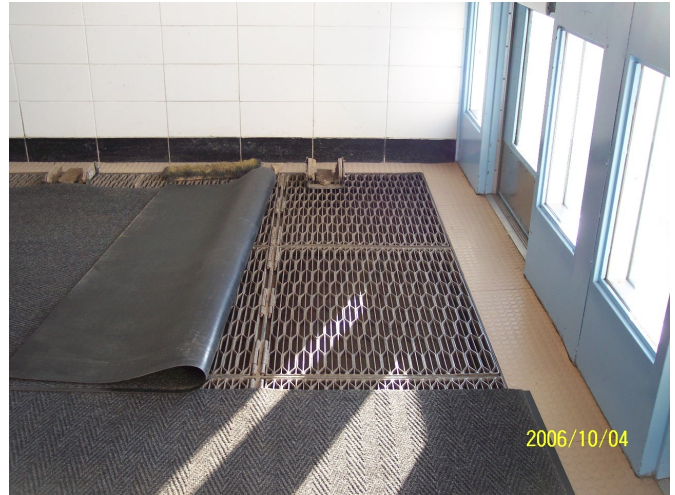
(1967) Addition - (Main Entrance) has recessed floor grilles.

<u>Rating</u>	<u>Installed</u>	<u>Design Life</u>	<u>Updated</u>
3 - Marginal	0	0	MAR-07

Event: Replace with concrete floor finish.
