RECAPP Facility Evaluation Report

Edmonton School District No. 7

Mount Royal Elementary School

B3229A
Edmonton

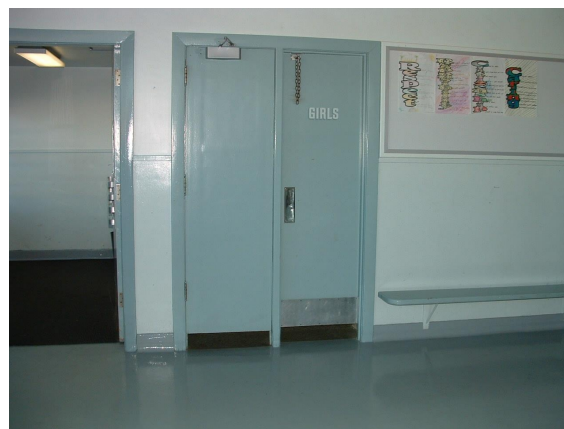
**K4010.04 Barrier Free Washrooms**

(2004) Barrier free items were incorporated during complete upgrade of Boys' and Girls' Washrooms.
