Asset Assessment Report

St. Michael's Health Centre (New) B0593B

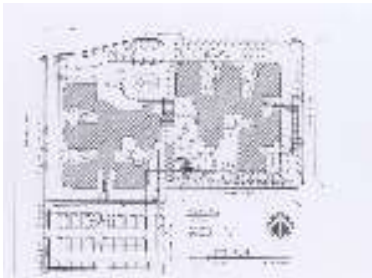
Site Plan

Description
 Site plan drawing provided by Health Region maintenance staff.
 Prime Consultant: Don Stewart - DC Stewart Architect Limited.
 Evaluation Date: Dec. 8, 2011.
