RECAPP Facility Evaluation Report

Alberta Hospital Edmonton MacPherson Building 10

B1022E
Edmonton

Facility Details	
Building Name:	Alberta Hospital Edmonton M
Address:	17480 Fort Road, P. O. Box
Location:	Edmonton
Building Id:	B1022E
Gross Area (sq. m):	9,570.00
Replacement Cost:	\$38,613,019
Construction Year:	1968

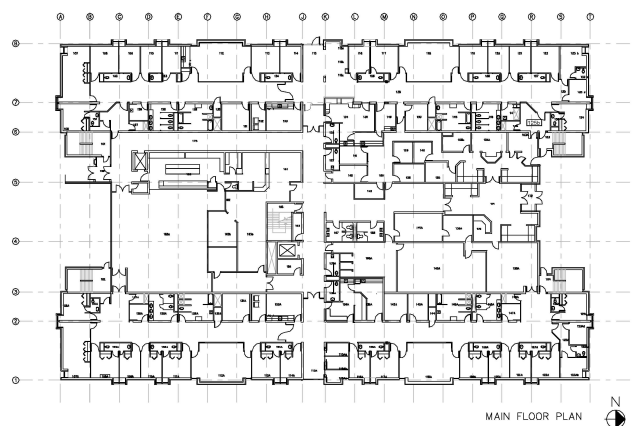
Main Floor.

Two storey structure with a penthouse and a partial basement below the south end of the building and an accessible crawl space below the north end. The building is linked at the basement via an underground walkway to the Food Services building to the west and to Building #9 to the East.
