# RECAPP Facility Evaluation Report

Alberta Health Services-North

**Queen Elizabeth II Hospital - Acute Care**

B1064A

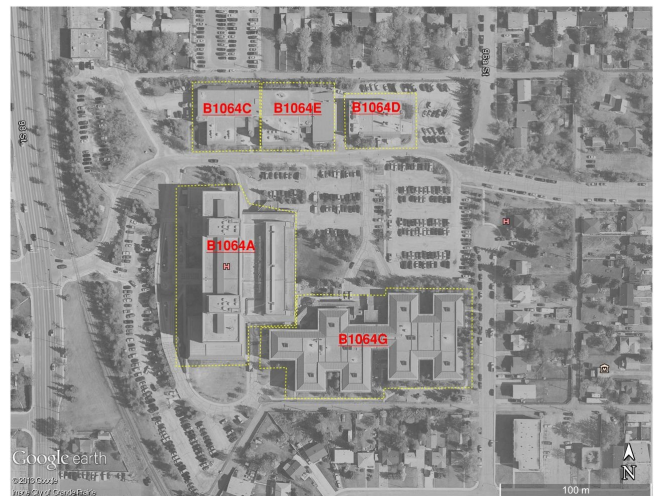
Site Description: Queen Elizabeth II Acute Care Building is a five storey general hospital located at 10409 98th Street in the City of Grande Prairie, Alberta.

Site and Site buildings.

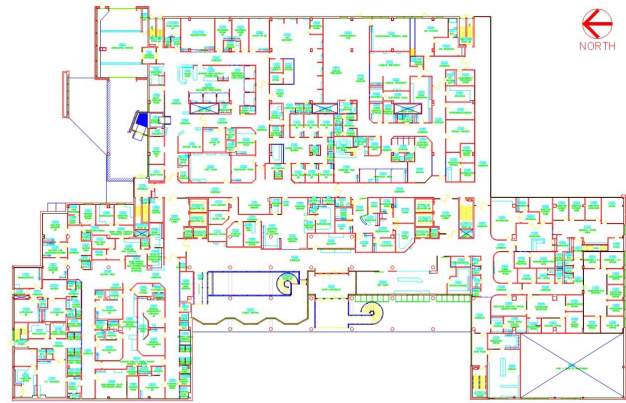
LEVEL 1 - FLOOR PLAN - FP01  
SCALE: N.T.S. DATE: 2012-OCT-12

5055A - Queen Elizabeth II Hospital, - Acute Care  
10409 - 98 St, Grande Prairie, AB
