RECAPP Facility Evaluation Report

Calgary School District #19

Cappy Smart Elementary School

B2566A

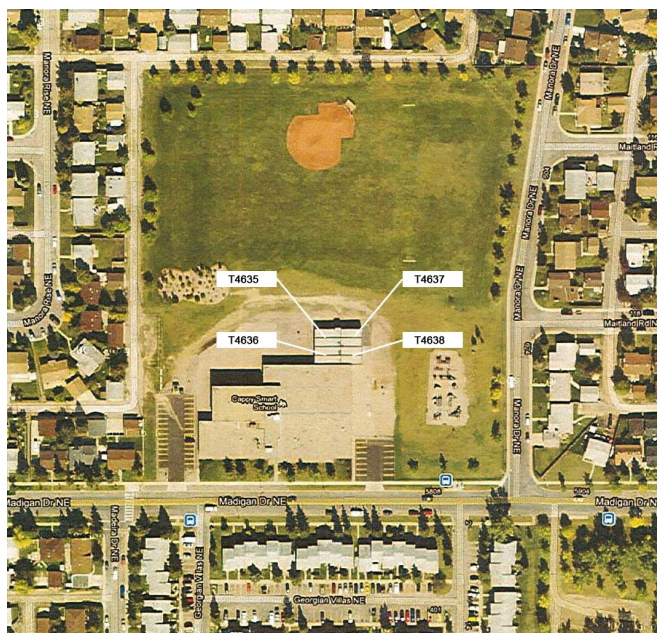
The school building is located on 5808 Madigan Drive N.E. with asphalt parking lot to the east and west. The main entrance faces south and is accessed form the municipal sidewalk by a concrete entrance walkway. The fields are contained within a chain link fence. Asphalt and gravel play field to the the east, north and west. Grassed play fields are shared with the city. The site is relatively flat. Drainage is generally away from the building to the west and south.

Google view of site with portables tagged
