RECAPP Facility Evaluation Report

Edmonton RCSSD #7

St. Gerard Catholic Elementary School

B3302A
Edmonton

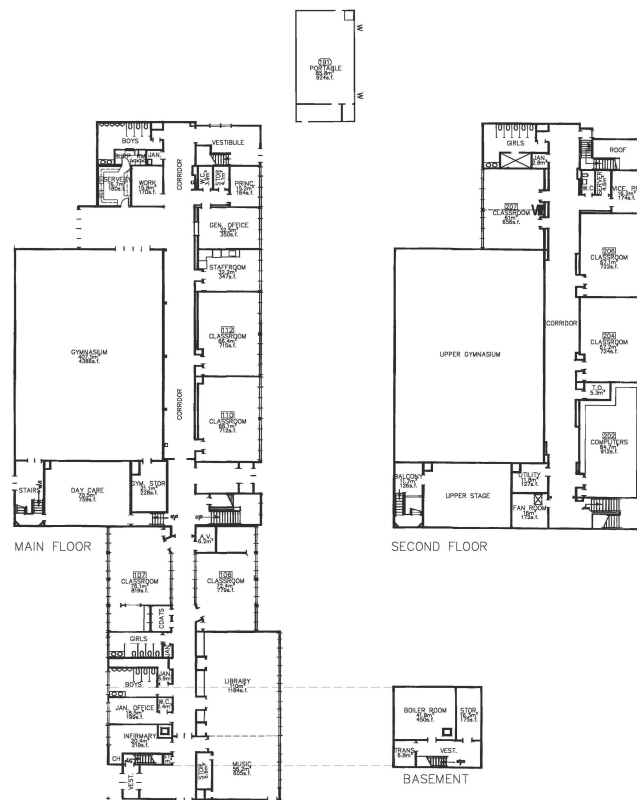
Basement, Main Floor and Second Floor Plans.

Basement, Main Floor and Second Floor Floor Plans.
