RECAPP Facility Evaluation Report

Calgary School District #19

Emily Follensbee Centre

B9120A

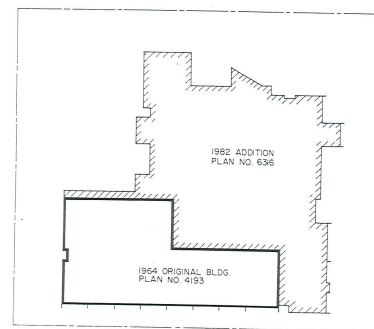
Site plan

PLT. ID.: 00319	SITE PLAN	DATE: 03/06/20	SCALE: 1:500
CORE: 8036		DRAWN BY: L.C.	SHEET: 1 of 4
ALGARY SCHOOL DIST. NO. 19			
EMILY FOLLENSBEE SCHOOL			
SCHOOL BUILDINGS SERVICES

The site is occupied by the Emily Follensbee School, which is located near the southeast corner of the property. The site features include a paved parking lot to the northeast of the building, a courtyard with landscaping and concrete unit and resilient composite paved surfaces to the southeast, and a play area to the south of the building. There are concrete sidewalks to each building entrance. The landscaped areas are provided adjacent to the south, east and west sides of the building. No irrigation systems are provided on-site. Drainage on landscaped areas is provided by land infiltration and/or overland flow.
